AIRCRAFT ACCIDENT REPORT

**ALOHA AIRLINES, FLIGHT 243
BOEING 737-200, N73711,
NEAR MAUI, HAWAII
APRIL 28, 1988**

NTSB/AAR-89/03

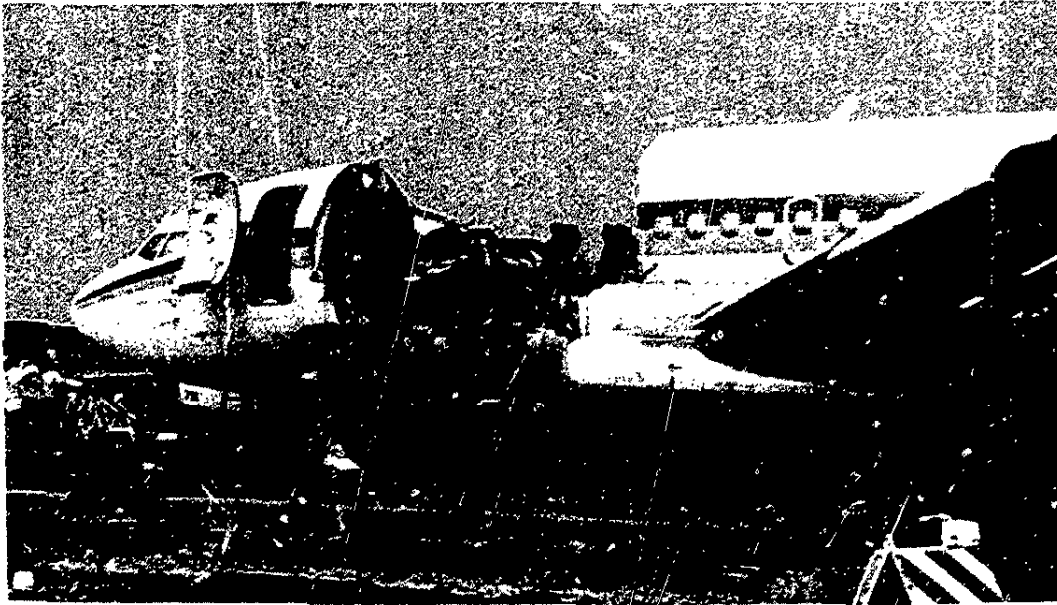
A major portion of the upper crown skin and structure of section 43 separated in flight causing an explosive decompression¹ of the cabin. (See figures 1 and 2.) The damaged area extended from slightly aft of the main cabin entrance door, rearward about 18 feet to the area just forward of the wings and from the left side of the cabin at the floor level to the right side window level.

Figure 2a.--General view, left side of forward fuselage, N73711

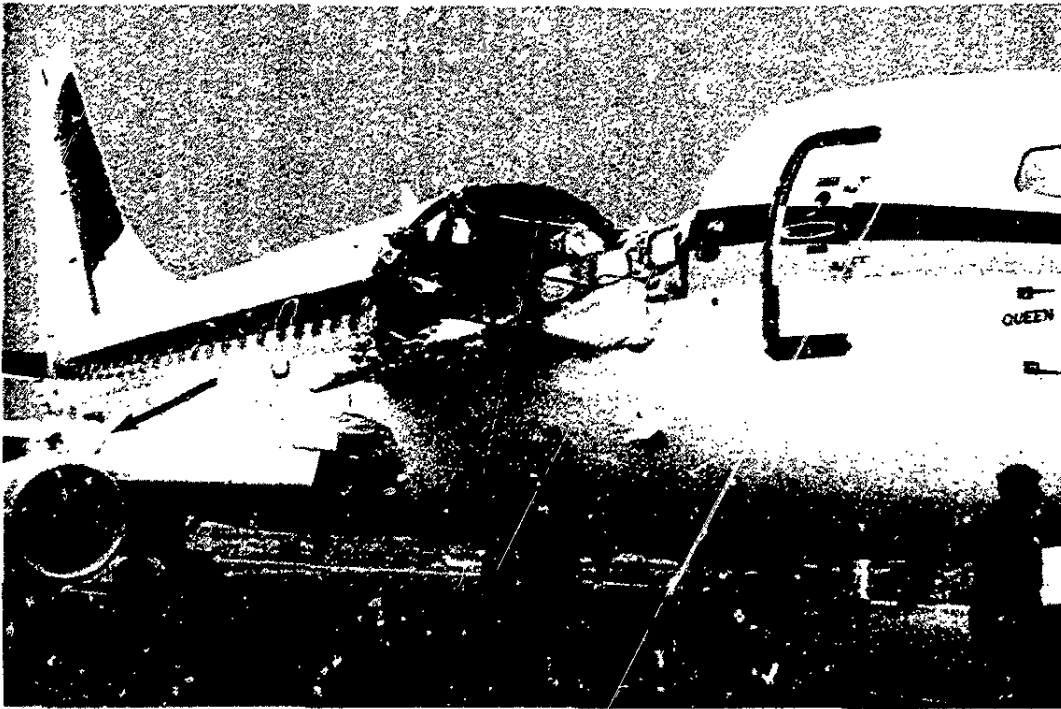
Figure 2b.--General view, right side of forward fuselage, N73711. Arrow marks fragments of S-4R lodged in the leading edge flap.

A fuselage section from BS 365 to BS 420 between S-4R and S-8R was trapped between the leading edge flap and inboard side of the right engine strut. This was the only significant piece of structure from the damaged
